*Case Study:*

# Reedsport, OR

*Municipal Wastewater Treatment Facility  
Performance Remediation & Energy Use Optimization*

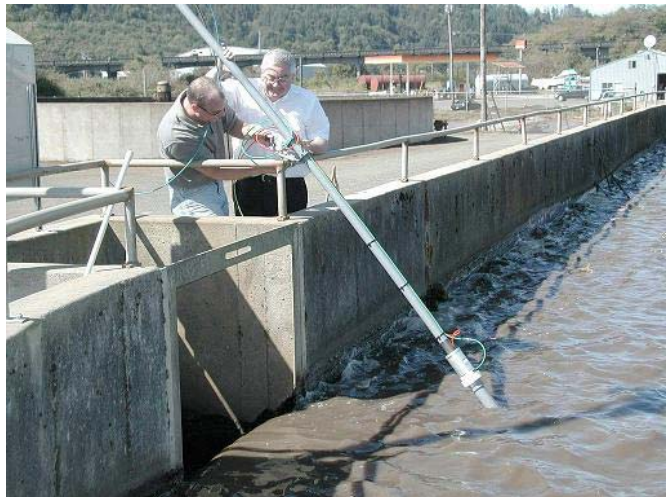
As a first step, a highly reliable, self-cleaning Dissolved Oxygen/Suspended Solids probe (shown above) was installed in each of the two primary aeration basins. Signals from the probes were acquired by a Programmable Logic Controller (PLC) located in the facility’s Motor Control Cabinet. The PLC was then connected to a Windows-based PC so the operators could access data and change control parameters without having to learn proprietary PLC programming menus.

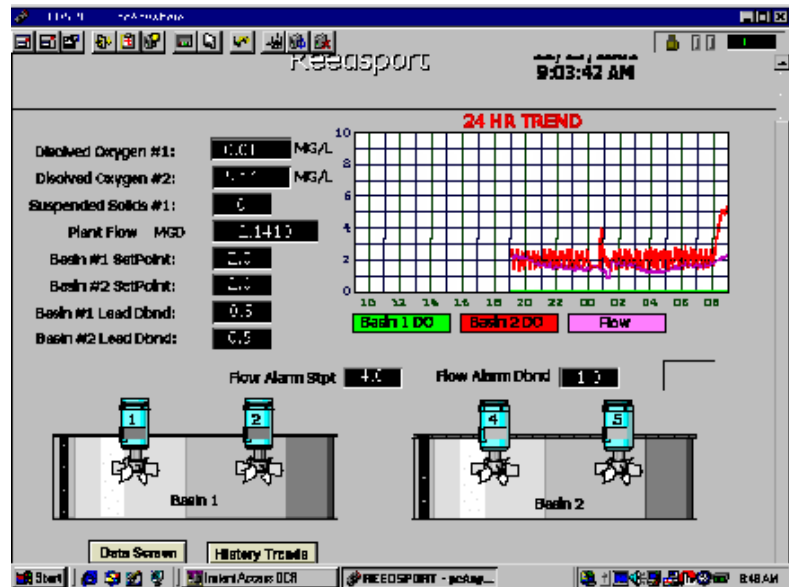
Cognizant of the mixing element, BacGen also programmed DO control “logic overrides” that forced the aerators to run at pre-set intervals, regardless of Dissolved Oxygen demand. This allowed the operators to feel comfortable leaving the system in an automated mode overnight and on weekends.
